# CROSS

## Confidential Reporting on Structural Safety

### NEWSLETTER No 36, OCTOBER 2014

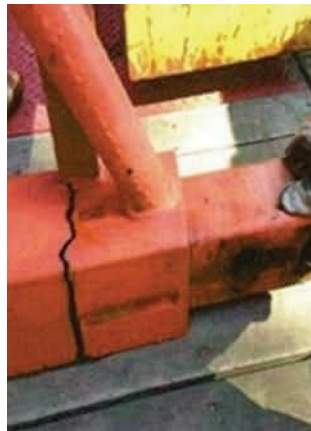
A tower crane suffered a failure of one of its four main legs approximately 12m below the slew ring. The fault was discovered, says the reporter, as a result of the tower crane operator noting some unusual banging and vibrations from what he believed to be the slewing ring. The crane was immediately taken out of service and an inspection carried out. This revealed that there was no fault with the slew ring but identified a failure in the leg. The crane was dismantled, the part replaced, and a new Certificate of Thorough Examination was issued by an independent company. At the time of reporting it was not known what caused the failure and a full investigation is underway. This incident has been reported to the HSE as a dangerous occurrence and the contractor issued an instruction to all sites to immediately carry out appropriate inspections of such cranes in consultation with the tower crane provider/operating company. In an update the reporter has pointed out the recommendations from

Crane in position

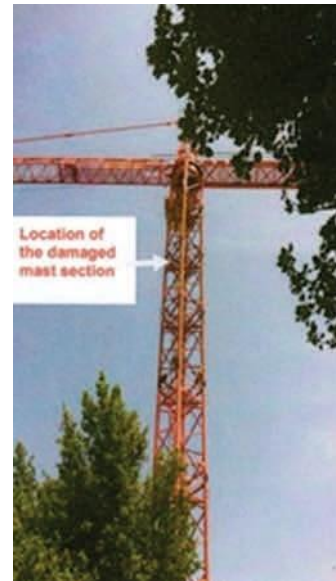
Fractured section

*The investigation is not yet complete but an obvious candidate for a failure of this kind is fatigue cracking. There are two phases of fatigue damage: crack initiation and crack propagation. Both phases are linked to repeated application of stress. Fatigue cracking is a potential mode of failure on any moving structure but its initiation and rate of propagation are rather uncertain. Hence a fundamental plank of safety is the ability to inspect with the objective of detecting a crack before it progresses far enough to be dangerous. This is a really good example of a near miss from which we can all learn. Any piece of steelwork which is subjected to repeated and/or cyclic loading should be inspected for fatigue loading. The incident supports the need and obligation for regular inspections but also to consider whether the usage of a crane in some circumstances might warrant more frequent inspection? For example, lighter loads but very frequent and repetitive use (creating reversals of stress) may be more harmful than occasional heavy loads. The recommendations in [CPA TIN042](#) are to be welcomed. There are other structures which are composed of a kit of parts each of which may have had a different history of use; for example temporary stages or even scaffolding. The history/residual fatigue life of the individual components will probably not be known. Is there a need for more rigorous systems for detecting fatigue in construction equipment components? It is taken very seriously in the aircraft industry.*

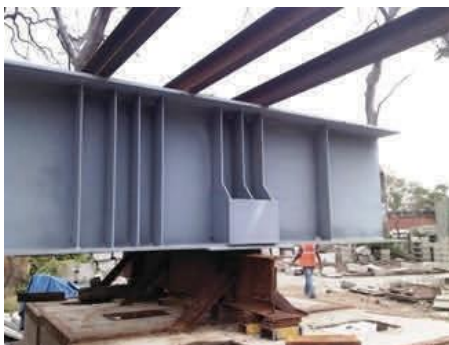
A composite steel girder was designed to support the platform for a Metro Rail station and it was decided to do a working load test on it at the fabrication yard before erection. Unfortunately the load test setup failed due to over-estimation of the capacity of the ISMB (Indian standard steel beam) provided for supporting the girder.

- 1) A detailed 3D analysis simulated the design bearing load over the ISMB-300 member and it was found that the stresses in the member were more than 3 times greater than yield strength.
- 2) The design size of the Elastomeric bearing pad was greater than the flange width of the ISMB300 so the bearing area was insufficient.
- 3) The main cause of the failure of the load test was the lack of proper stiffening plates.

Test load setup

*Assuming that it was an overestimation of the strength of the supporting member then the lesson is that test rigs should be designed to the same level of detail as the piece being tested. SWL need to be defined for the test rig, as often the tested piece may be significantly stronger/stiffer than expected and loading to deflection/failure criteria of the test piece can fail the rig. As is so often the case attention to detailing is required. All elements on the load path need to be looked at - there is always a weakest point.*

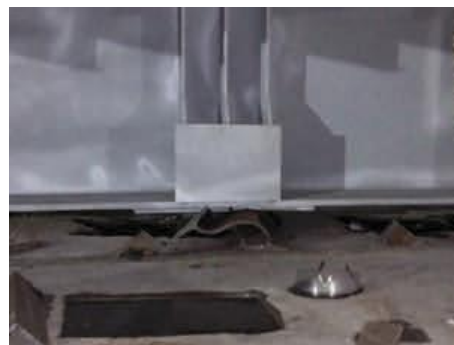
Remains of the supporting beam
