SCOSS TOPIC PAPER

December 2014

Elliot Mall Inquiry

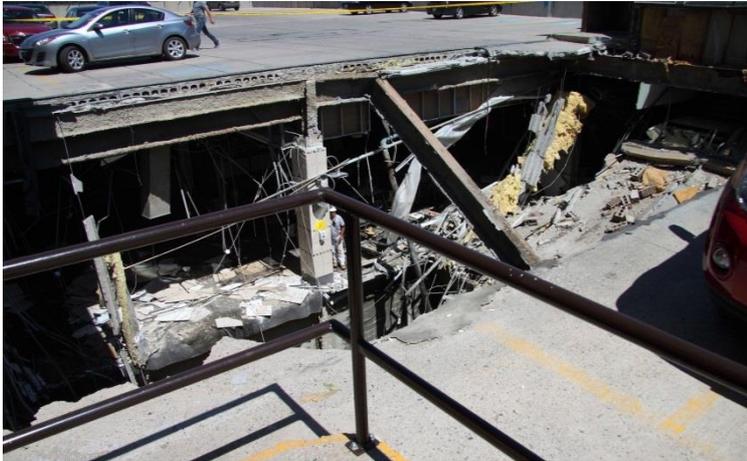
The collapsed roof structure

The Commission found that from day one the roof leaked and numerous attempts were made to fix it throughout the life of the building. Water found its way through joints, in between the slabs and the topping, onto the supporting steelwork, and into the retail units below. In winter the water contained de-icing salts. Over time the topping debonded in parts and there was significant corrosion of the structural steelwork.

Eventually there was a sudden collapse as a steel frame connection between a beam and a column failed and debris fell into the mall.
