SCOSS ALERT

February 2018

Fire in Multi-Storey Car Parks

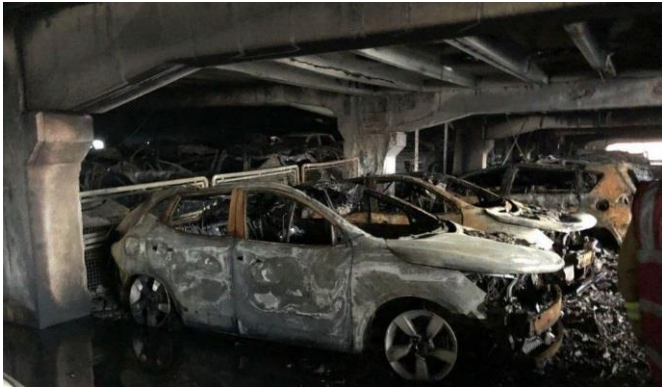
Figure 3: The scale of devastation. Image courtesy of MFRS.

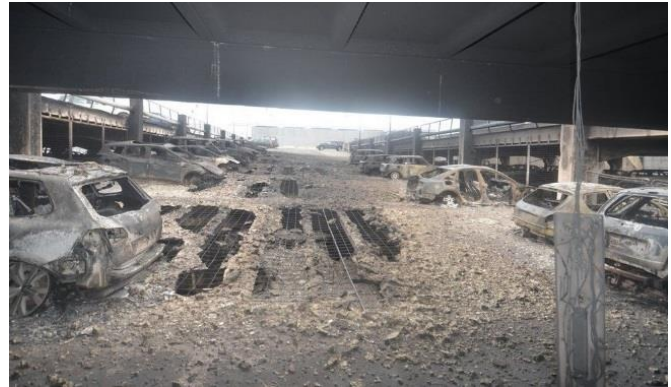
The car park was built in 2006 as part of the development of the Liverpool Echo Arena on land adjacent to the River Mersey. Overall size is approximately 70m x 60m with columns at about 7m centres in the shorter direction. There are four spans of beams in the longer direction and there are four concrete stair and service cores with fire doors onto the parking floors. As can be seen from the photograph in Figure 3, the columns and beams are substantial. Between the beams and spanning about 7m are precast ribbed floors and these have totally disintegrated down the middle of some floors and partially collapsed in other places as shown in Figure 4.

Figure 4: Disintegration of floor slab. Image courtesy of MFRS.
